July 9, 2015

Subject: Red and Bonita Mine, Silverton, CO
Site Visit Summary and Ground Control Plan

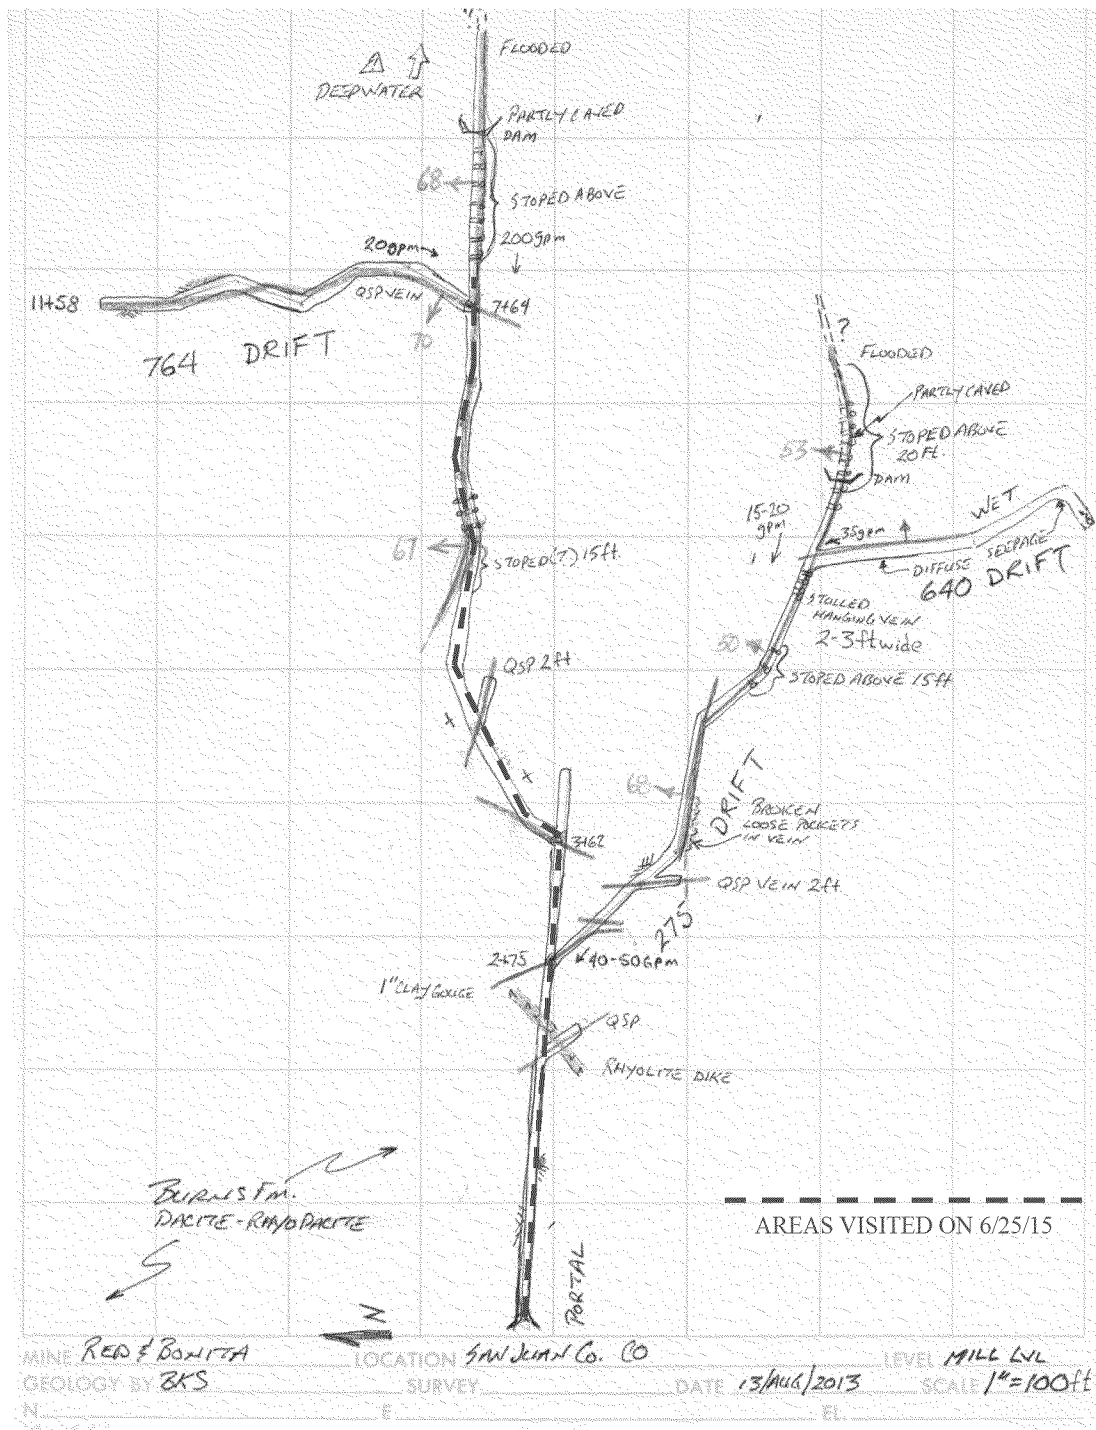
The work areas visited are marked on the DRMS map of underground workings of the Red and Bonita Mine below:

Figure 1: Detailed Map of Underground Workings
(modified from DRMS Red and Bonita Mill Level Survey Map; 2013)
